DEPARTMENT OF TRANSPORTATION**DIVISION OF ENGINEERING SERVICES**

Contract #: 04-0120F4Cty: SF/ALA Rte: 80 PM: 13.2/13.9File #: 1.28**WELDING INSPECTION REPORT****Resident Engineer:**Siegenthaler, Peter**Address:** 333 Burma Road**City:** Oakland, CA 94607**Report No:** WIR-024526**Date Inspected:** 21-Jun-2011**Project Name:** SAS Superstructure**OSM Arrival Time:** 700**Prime Contractor:** American Bridge/Fluor Enterprises, a JV**OSM Departure Time:** 1730**Contractor:** American Bridge/Fluor Enterprises, a JV**Location:** Job Site**CWI Name:** See Below**CWI Present:** Yes No**Inspected CWI report:** Yes No N/A**Rod Oven in Use:** Yes No N/A**Electrode to specification:** Yes No N/A**Weld Procedures Followed:** Yes No N/A**Qualified Welders:** Yes No N/A**Verified Joint Fit-up:** Yes No N/A**Approved Drawings:** Yes No N/A**Approved WPS:** Yes No N/A**Delayed / Cancelled:** Yes No N/A**Bridge No:** 34-0006**Component:** Orthotropic Box Girder & Tower**Summary of Items Observed:**

WELDING INSPECTION REPORT

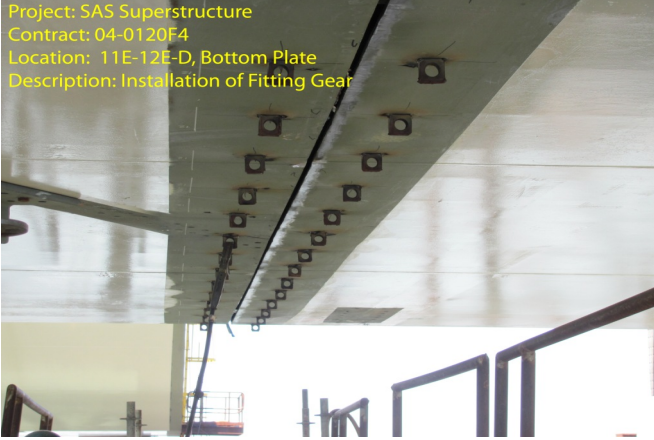
The QAI observed the fillet welding of the fitting gear to the bottom plate to be utilized during the alignment process of the field splice identified as D1 and D2. The field fit-up and welding was performed by Rick Clayborn ID-2773 utilizing the SMAW process as per the WPS identified as ABF-WPS-D15-F1200A Rev. 1. The WPS was also used by the QC inspector William Sherwood as a reference to verify the DCEP welding parameters and were noted as follows: 128 amps. The QAI also observed the QC inspector verify the surface temperatures which appeared to comply with the contract documents.

Project: SAS Superstructure
Contract: 04-0120F4
Location: 11E-12E-D, Bottom Plate
Description: Installation of Fitting Gear
